Hardware Errata

This page lists some issues with CPU board hardware, as they are discovered, and some workarounds.

Rev 1

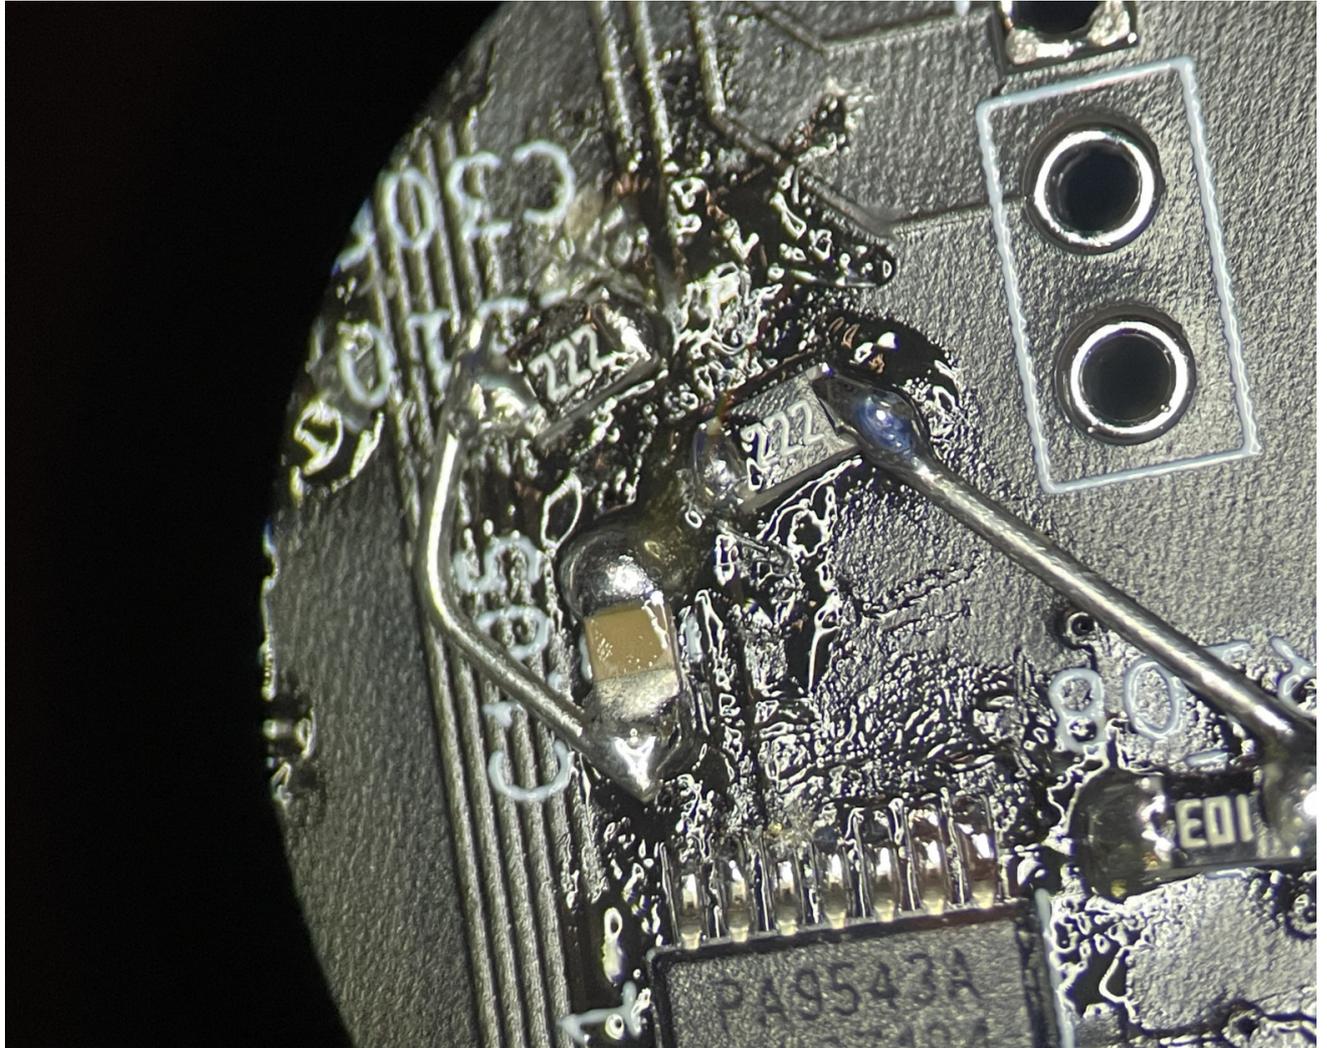
- Switched front/rear I²C bus (from mux to MCU) is missing pull ups
 - Need to insert these between the mux (U101) and microcontroller

- o Rework required: Bodge in a pair of 2k2 resistors to +3V3
