# CPU Board

The thing that runs the show

- Peripheral Allocation
- DMA Channel Allocations
- Clocking
- Hardware Errata

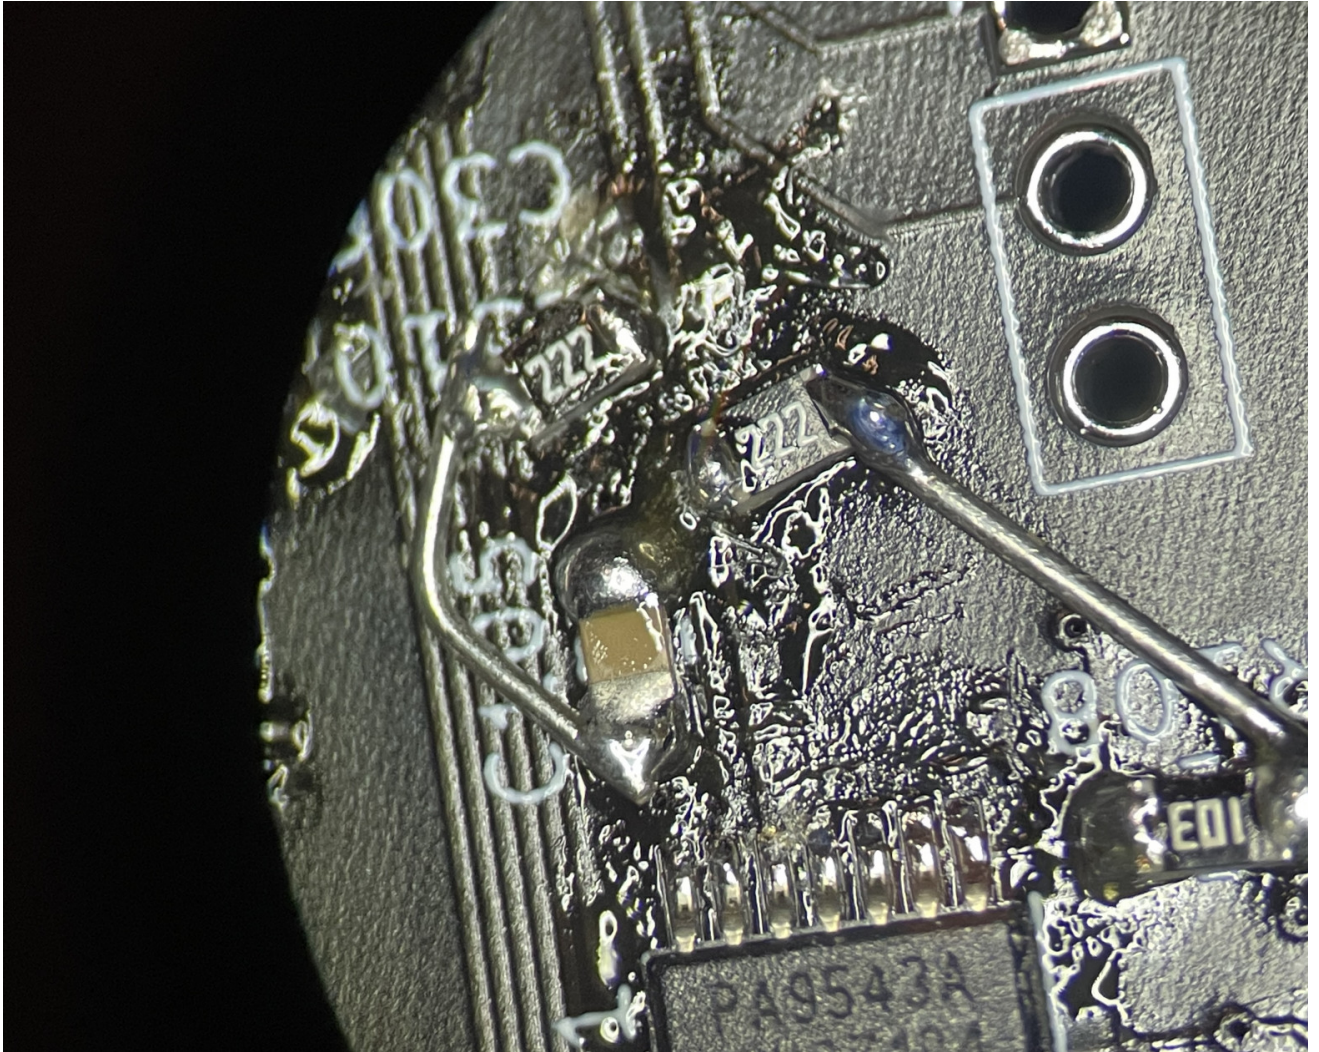
- Switched front/rear I<sup>2</sup>C bus (from mux to MCU) is missing pull ups
  - Need to insert these between the mux (U101) and microcontroller

- Rework required: Bodge in a pair of 2k2 resistors to +3V3
